### CARBON COUNTY PRELIMINARY ENGINEERING REPORT CHANCE ROAD BRIDGE OVER THE CLARKS FORK OF THE YELLOWSTONE RIVER (MDT# - L05129001+05001) (COUNTY BRIDGE #CR3)

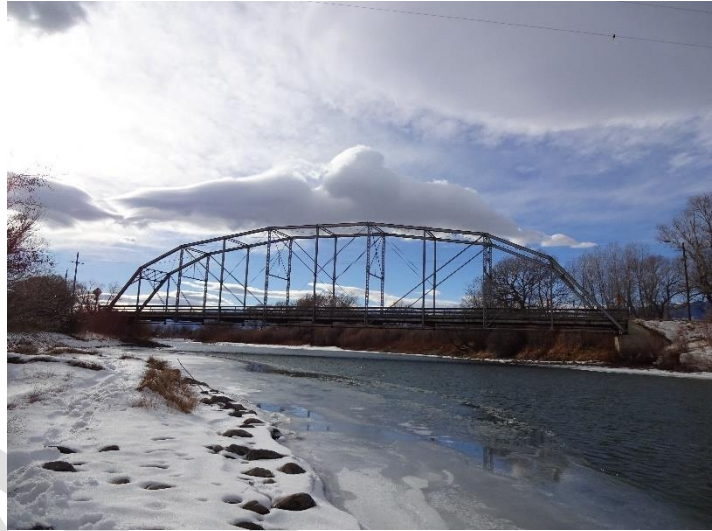
The existing bridge is classified as a single-lane, single-span, steel through-truss bridge with a timber deck and cast-in-place concrete abutments. The bridge superstructure has a total span of 203 feet. The total bridge width is 16 feet, while the useable width is approximately 15.5 feet due to the configuration of the bridge rail. The clear opening between the lower chord of the truss and the streambed is approximately 14 feet. Discussions with the MDT indicate the bridge abutments were constructed in 1946 while the truss was originally built in the early 1900's and was part of the Huntley Bridge over the Yellowstone River before being moved to its current site. Periodic maintenance and repairs have been made including replacement of object markers, installation of load posting signs and replacement of timber deck members.

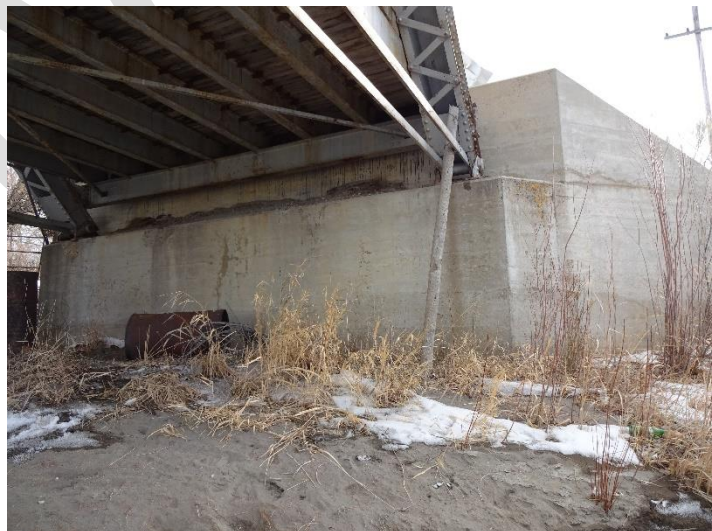
The bridge foundation consists of cast-in-place concrete abutments. The support system for the abutments is unknown and is likely either concrete footings or piles. Wingwalls are present at each bridge corner and consist of 15-inch wide cast-in-place concrete at a length of 10-feet and angled at 45 degrees to the bridge. A 12-inch wide cast-in-place concrete backwall is present behind the truss ends and extends the full bridge width.

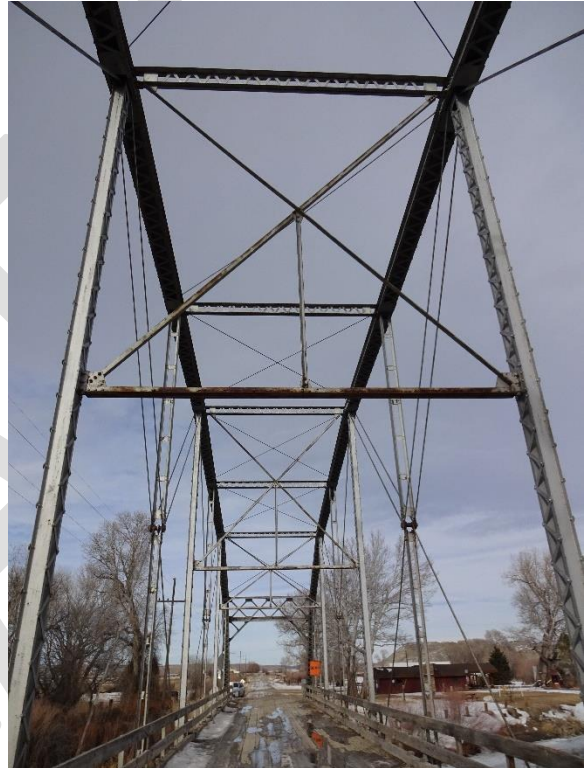
A supplementary field inspection of the Chance Road Bridge was performed by Great West Engineering personnel in January of 2016. The inspector concluded that the deteriorating superstructure and material components, have led to its

current load limited and structurally deficient condition. Refer to the structure photos in Appendix II of this report. The following is a summary of the most serious deficiencies of the bridge.

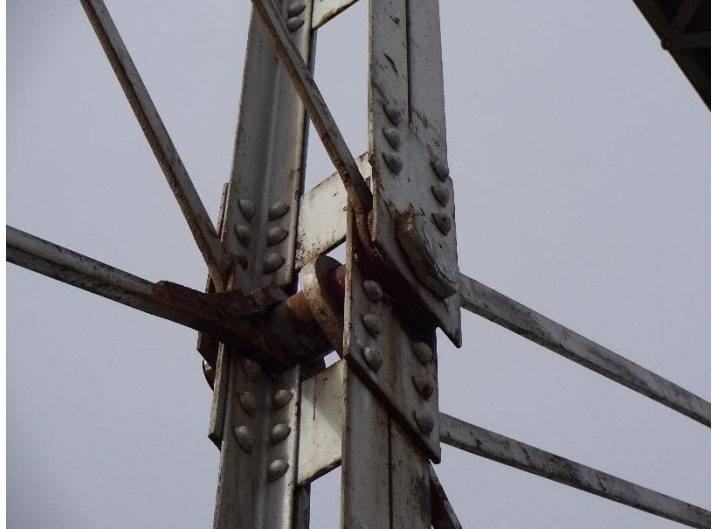
According to MDT documentation, the bridge abutments were originally constructed in 1946 and the steel overhead truss was salvaged from a structure constructed in the early 1900's. This would mean the truss was likely made of mild steel. Mild steel was widely popular

prior to the early 1900's, but is undesirable today due to low values of tensile strength and yield strength. As a result of the steel's strength and truss member sizes, the Type 3 inventory rating was determined to be only 3 tons. The reduction of the steel structure's strength due to mild steel is compounded by the paint failure on the steel truss members, which is causing surface rust, pack rust, pitting and corrosion on all primary steel elements of the superstructure (truss, stringers, and floor beams). The steel stringers, floorbeams and truss frame exhibits deformations and areas of collision damage. The bridge bearings are in poor condition with corrosion, pack rust and appear to be seized. The truss superstructure is considered to be a fracture critical structure as there is no load path redundancy. Load path redundancy means that if one critical member of the truss were to fail, whether from collision or overloading, the entire structure is rendered susceptible to failure.

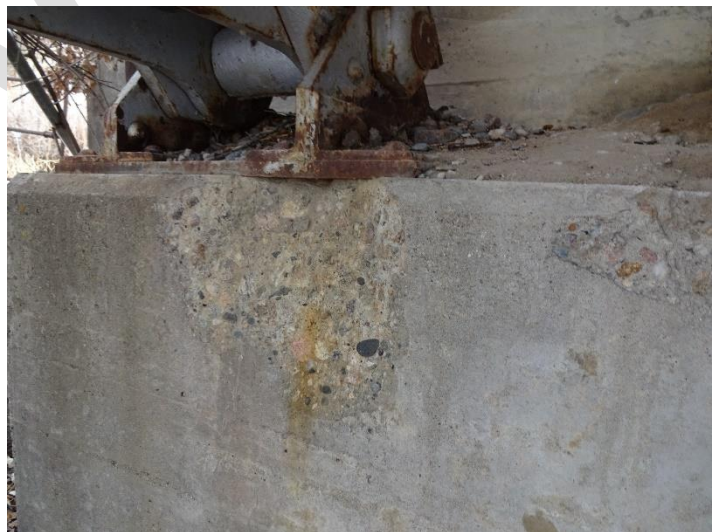
The substructure consists of cast-in-place concrete abutments and is in fair condition. The footing configuration/construction is unknown due to lack of as-built drawings and absence of visual clues during inspection. It is likely that the abutment is either supported by timber piles or concrete footings. In general, most exposed concrete surfaces of the

abutments and wingwalls exhibit cracks, spalls and rock pockets. Minor erosion is also present along the back face of the wingwalls, as these wingwalls are insufficient in retaining the current fill slopes due to their size and length.

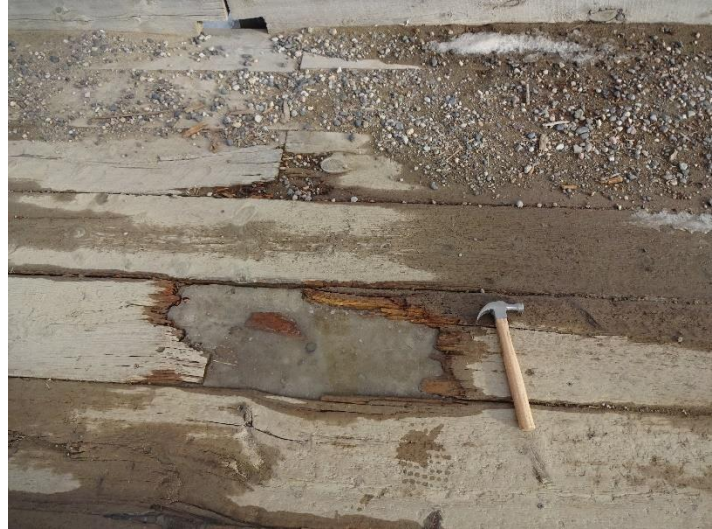
The timber deck is in fair condition with areas of surface decay, end checks and member rotation. The timber running planks are in poor condition with decay, heavy wear and section loss.

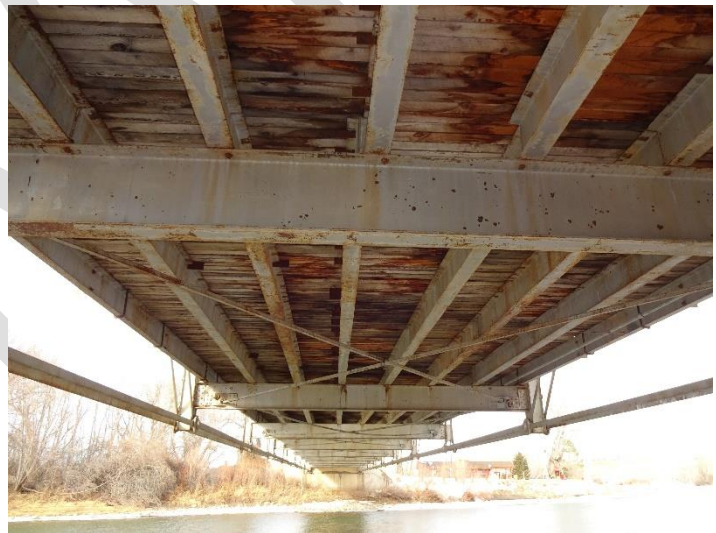
Overall, the condition of the existing bridge is poor. There are serious structural issues with the condition and load-limited capacity of the steel truss, which have led to the current posting of 3 tons. Repairs to the Chance Road Bridge include installation of a

new superstructure, modifications to the concrete abutments to facilitate bridge widening, new bridge rail and installation of approach guardrail and terminal end sections. As the original structure requires significant work on the superstructure and significant repair work, it is in the best interest of the County to replace the entire bridge rather than conducting repairs. A new structure would have a useful life of 75 years and require substantially less maintenance. The replacement structure will also allow for two-way traffic with the capacity to convey legal loads.

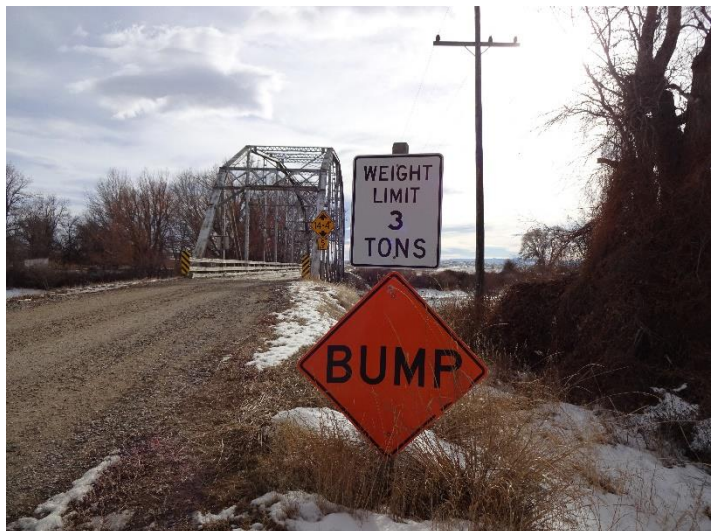
The existing bridge is incapable of carrying heavy truck traffic due to the load limiting superstructure. If the bridge is not replaced, the superstructure deterioration will create a greater safety concern and liability for the County. The bridge is already posted at the lowest allowable capacity and any further measurable deterioration that affects the load capacity will result in the closure of the bridge. The replacement structure should be constructed to handle HS 20-44 or, if possible, the more current HL-93 loading requirements.
